FAILURE ANALYSIS OF CENTRIFUGAL PUMP (OVERHUNG 212–P17) USING FMEA METHOD AT PT KILANG PERTAMINA INTERNASIONAL RU II DUMAI

Karnova Yanel^{1*} Rozi Saferi² Ismet Eka Putra³

^{1 2 3}Program Studi Teknik Mesin, Institut Teknologi Padang, Indonesia

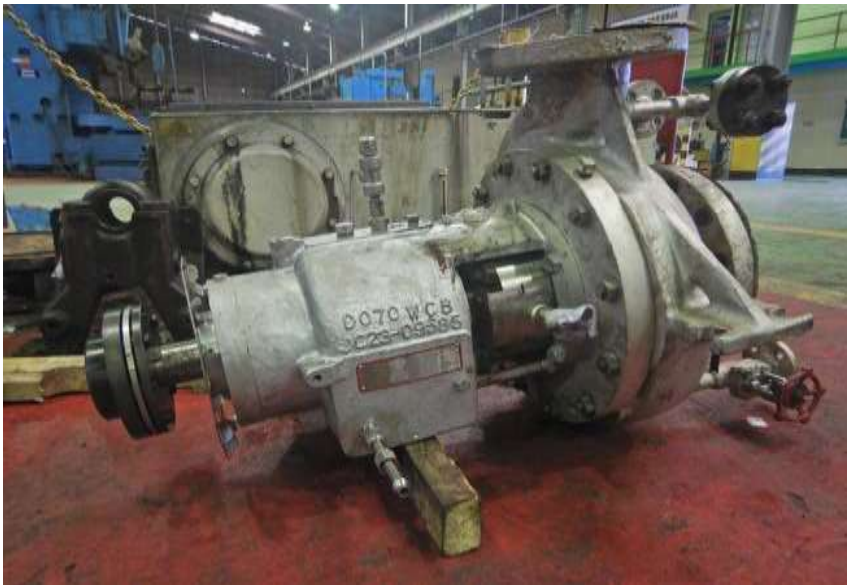
Figure 1 Photo of Overhung Pump 212 P-17

Table 1: FMEA scores and RPNs for pump 212–P17 failure modes. The RPN values for shaft misalignment and lubrication are the highest (60), indicating these as the most critical failure modes. The Overhung Centrifugal Pump 212–P17 during maintenance and inspection work conducted in the workshop following an operational failure in the field (Figure 1). The pump has been disassembled, revealing key internal components such as the impeller, casing, and shaft. Evidence of wear and mechanical damage can be observed on the wearing surface between the impeller and casing. Scratch marks and signs of metal contact are visible, indicating that excessive friction occurred—likely due to shaft misalignment or insufficient clearance. This image supports the mechanical failure analysis by visually demonstrating symptoms identified during the disassembly process.

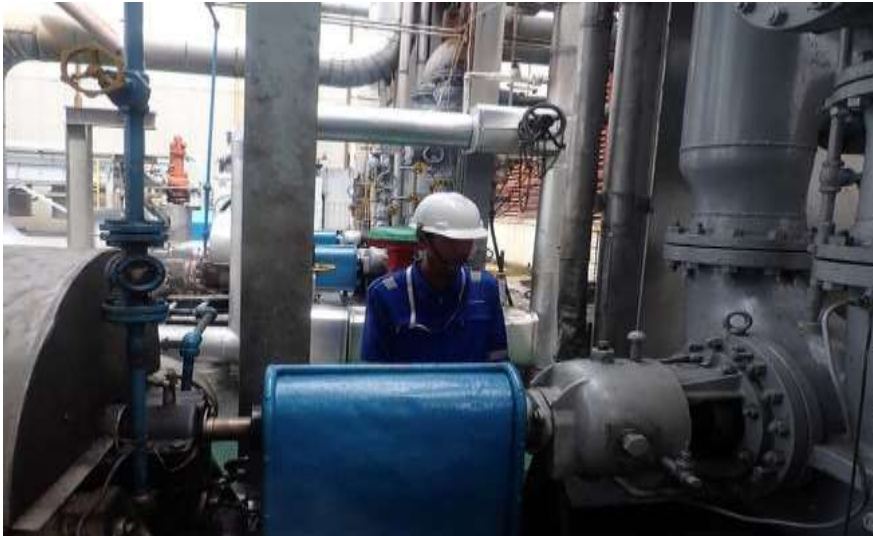
Figure 2 Field Photo of Overhung Pump 212 P-17

Field installation of Overhung Centrifugal Pump 212–P17 in its operational setting at PT Kilang Pertamina Internasional RU II Dumai (Figure 2). The pump is mounted horizontally and integrated into the piping system that transports high-temperature fluid, specifically Net Heavy Kerosene at approximately 271°C. The photo provides an overview of the pump’s environment, including the inlet and outlet lines, support structures, and adjacent equipment such as heat exchangers. This contextual image is essential for understanding operational stresses, including thermal expansion, vibration exposure, and space constraints affecting maintenance accessibility. It complements the workshop image by providing a broader picture of the pump’s operating conditions prior to failure.
